**FIELD OVERSIGHT SUMMARY REPORT**  
**ACS NPL SITE**  
**GRIFFITH, INDIANA**  
**March 29, 1997 - May 31, 1997**

Oversight Summary Report

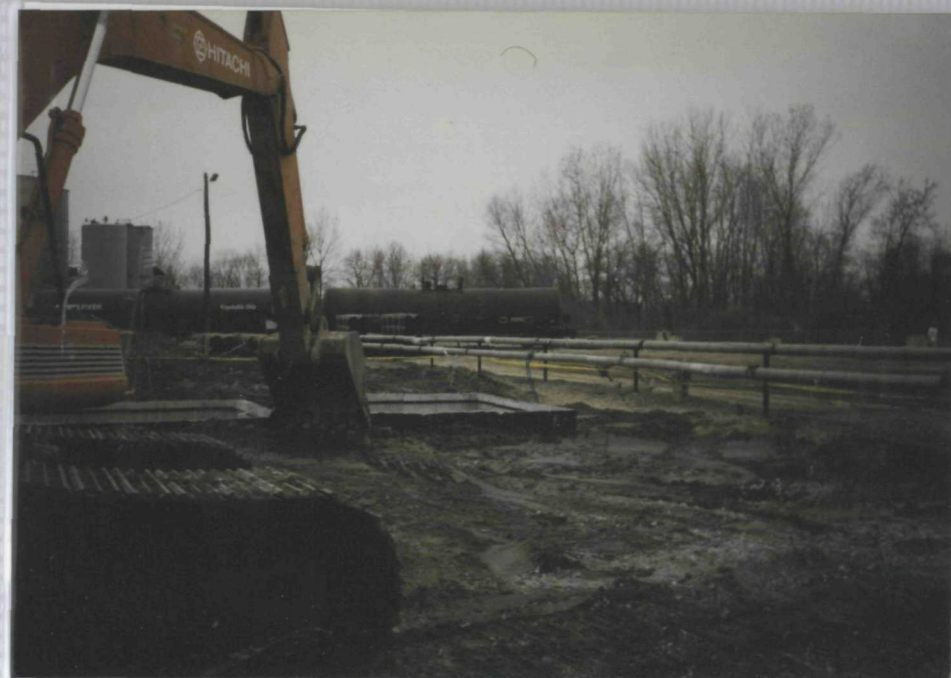
Description: Facing south-west. Backfilling around the three settling tanks is nearly completed.

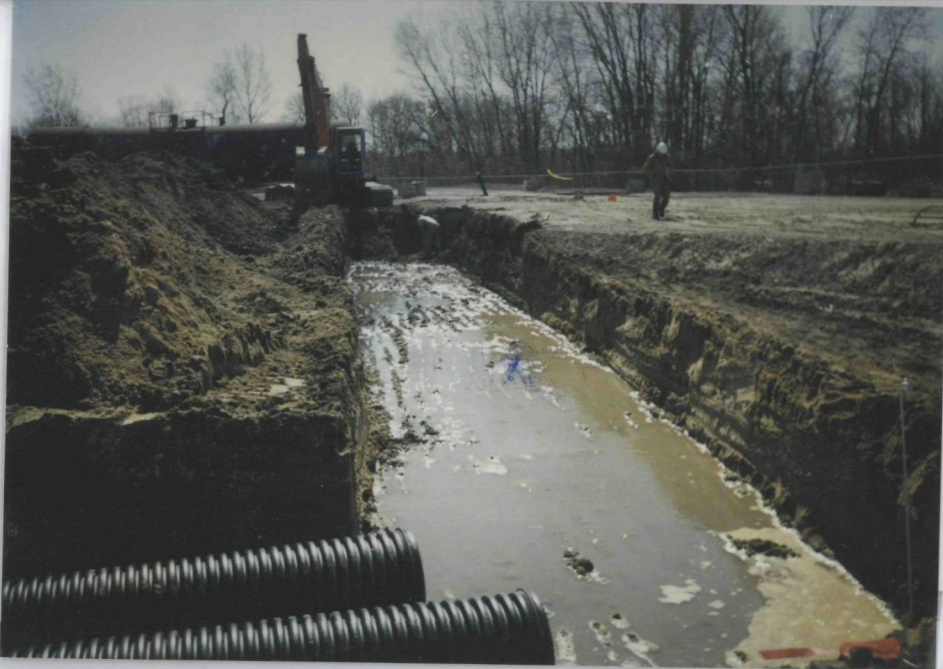
Site: American Chemical Services, Inc. RD/ERA  
 Proj. #: 71670.600  
 Roll: 3 Photo #: 99  
 Date: 04-07-97 Time: 1440  
 Photographer: Ashok Rupani  
 Description: Facing south. Excavating to install two 18-inch, corrugated, outflow, HDPE pipes for the stormwater collection system.

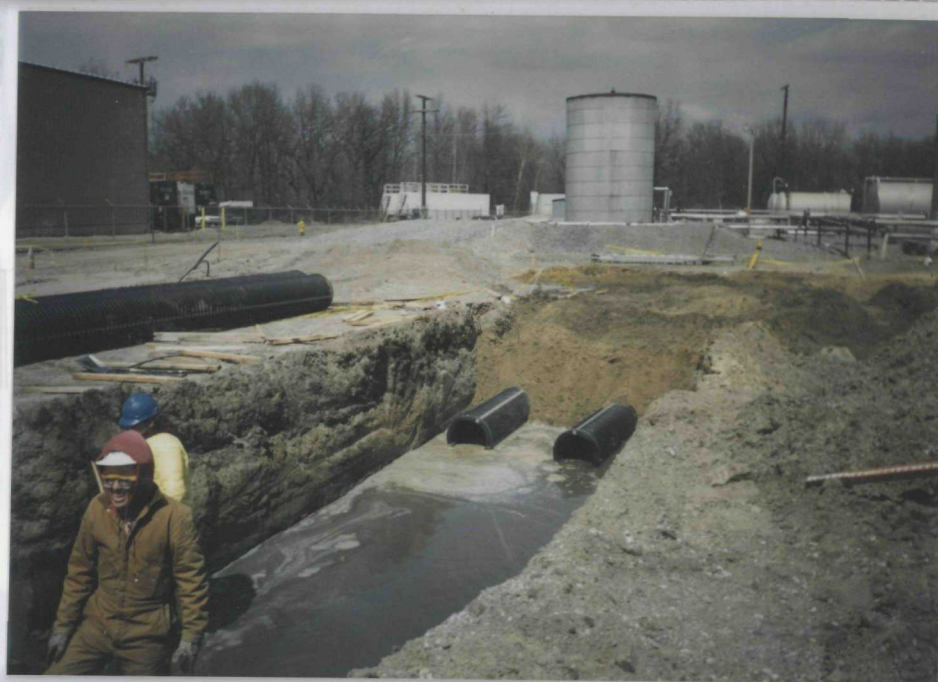
Site: American Chemical Services, Inc. RD/ERA  
 Proj. #: 71670.600  
 Roll: 3 Photo #: 100  
 Date: 04-08-97 Time: 1400  
 Photographer: Ashok Rupani  
 Description: Facing north-west. Installing stormwater piping which runs from the western settling tank to the drainage ditch which runs into the wetlands.

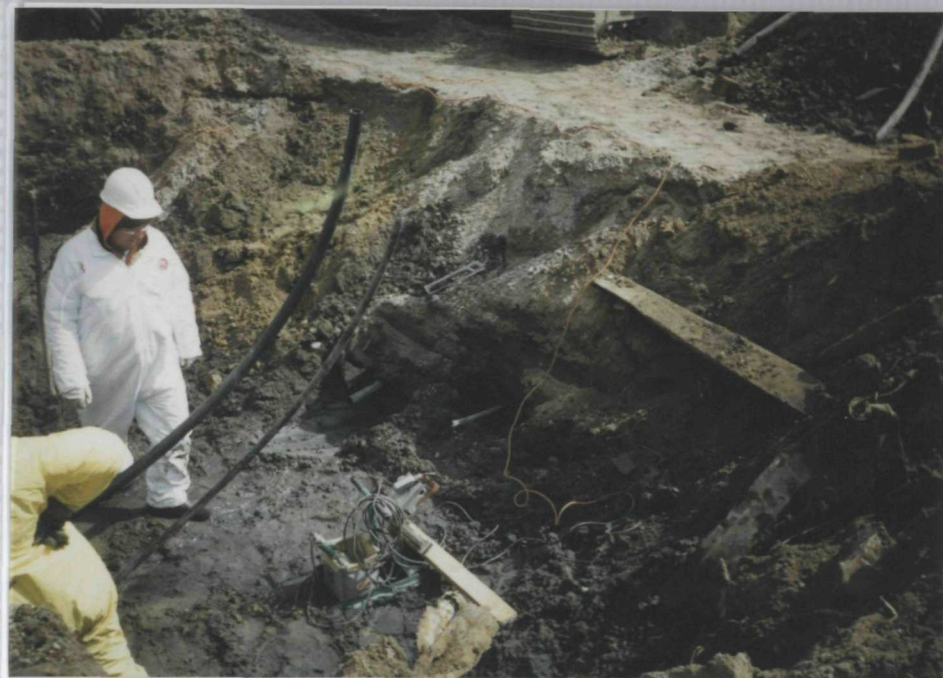
Description: Facing east. While excavating to install stormwater piping, the BWES conveyance piping, installed earlier by Youngs, was accidentally damaged. The photo shows Montgomery Watson personnel getting ready to repair the BWES conveyance piping.

On April 8, 1997, during the construction of the ACS stormwater collection system, ACS subcontractor accidentally damaged the BWES conveyance piping while installing the outflow lines from the tank system to the wetland drainage ditch. Montgomery Watson personnel worked with the subcontractor crew and re-fused the piping together.

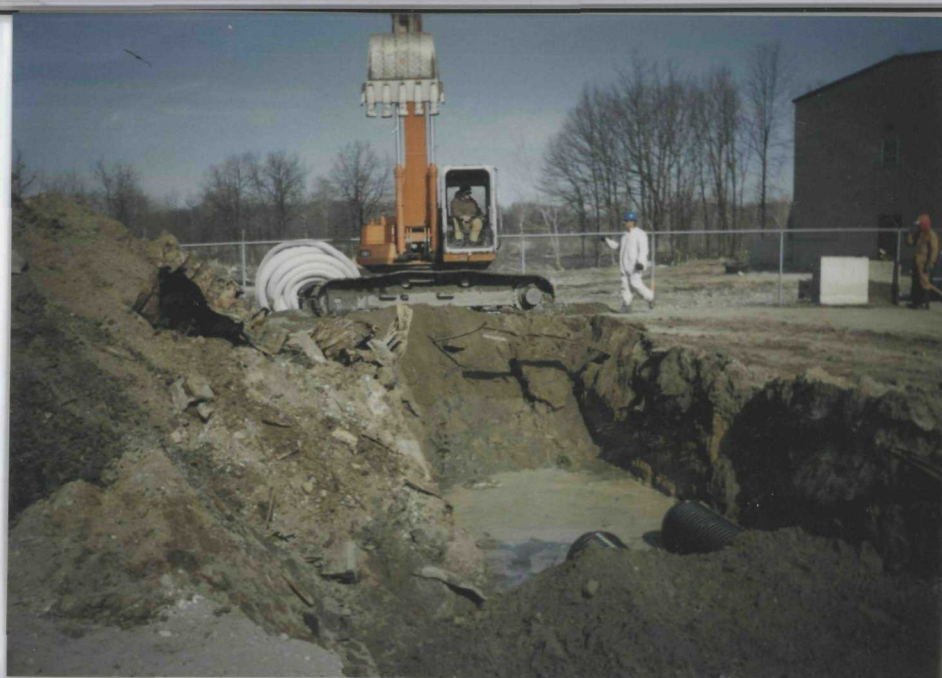
Description: Facing south-west. Excavating to install stormwater piping near the ACS fence.

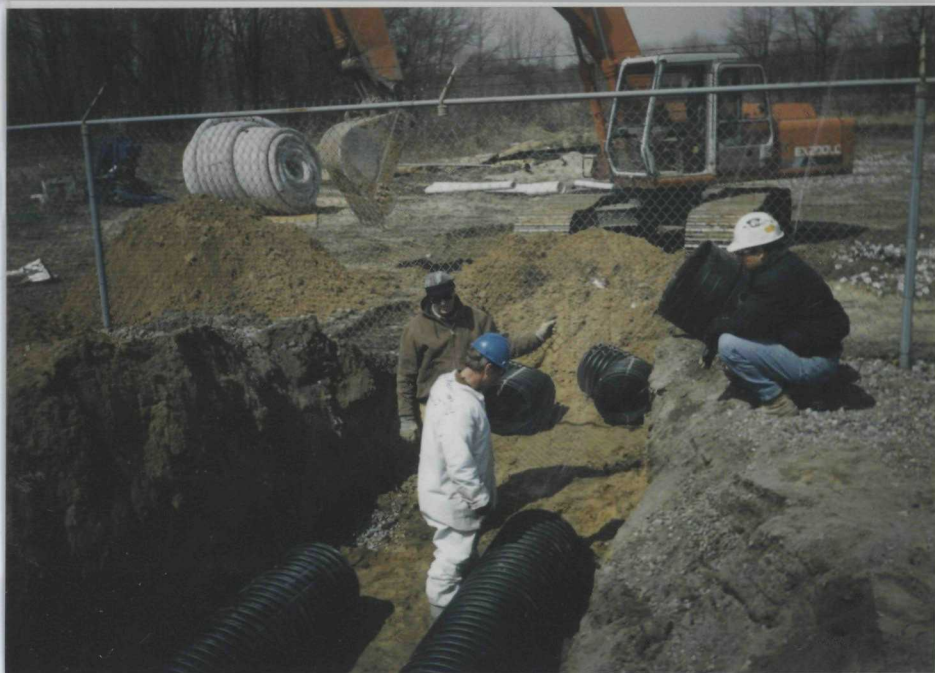
Description: Facing south-west. Installing stormwater piping near the ACS fence. The excavation continued through the fence by under-digging.

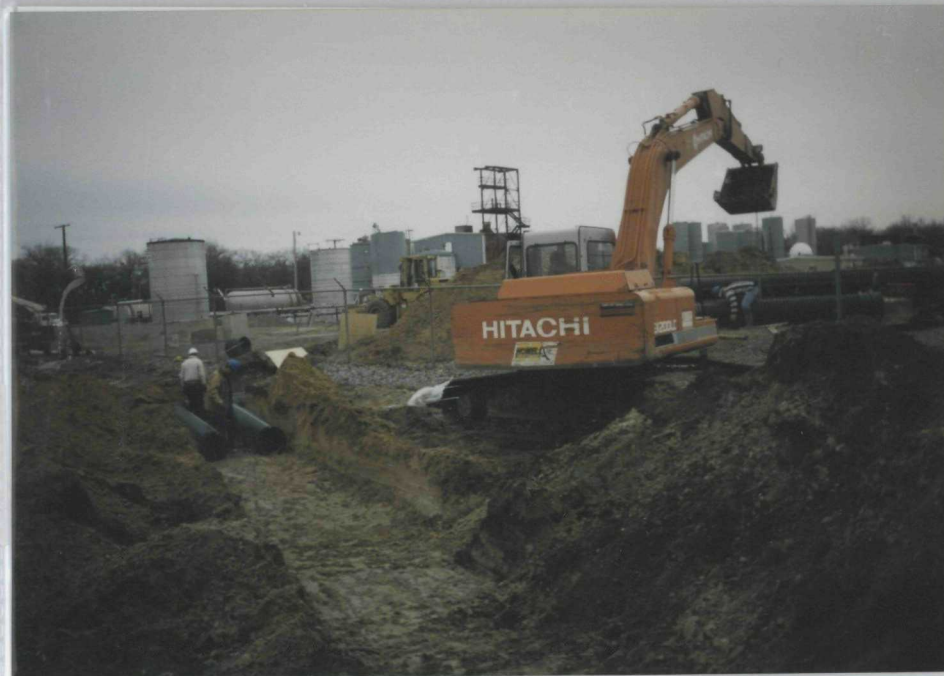
Description: Facing north. Installing stormwater piping outside the ACS fence and continuing towards the drainage ditch.

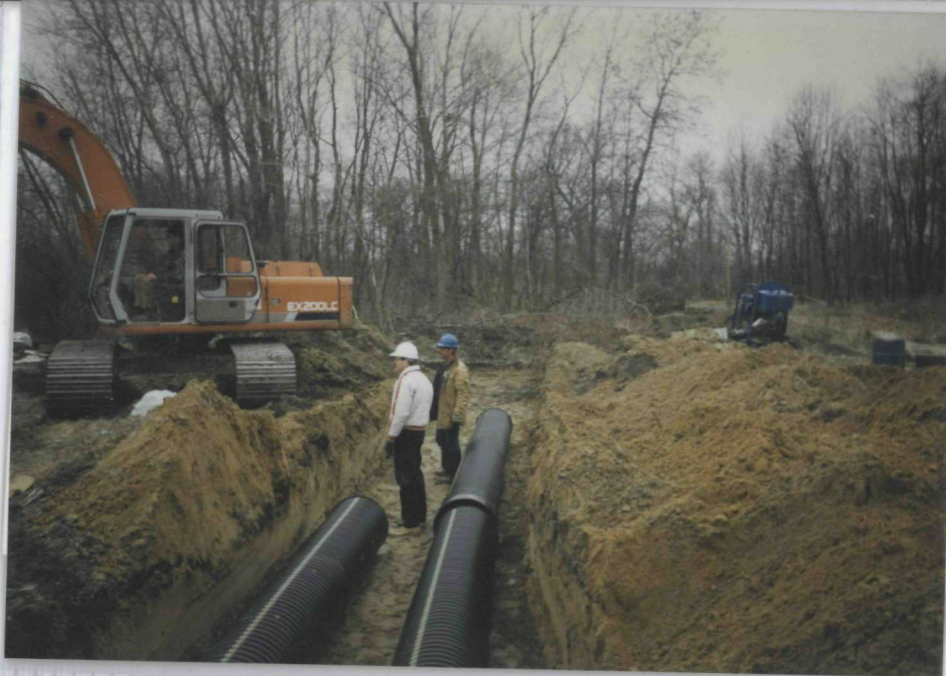
Roll: 3 Photo #: 107  
 Date: 04-10-97 Time: 1300

Description: Facing north-east. Several pieces of metal and crushed drums were encountered while excavating for stormwater piping a few feet east of the ACS fence.

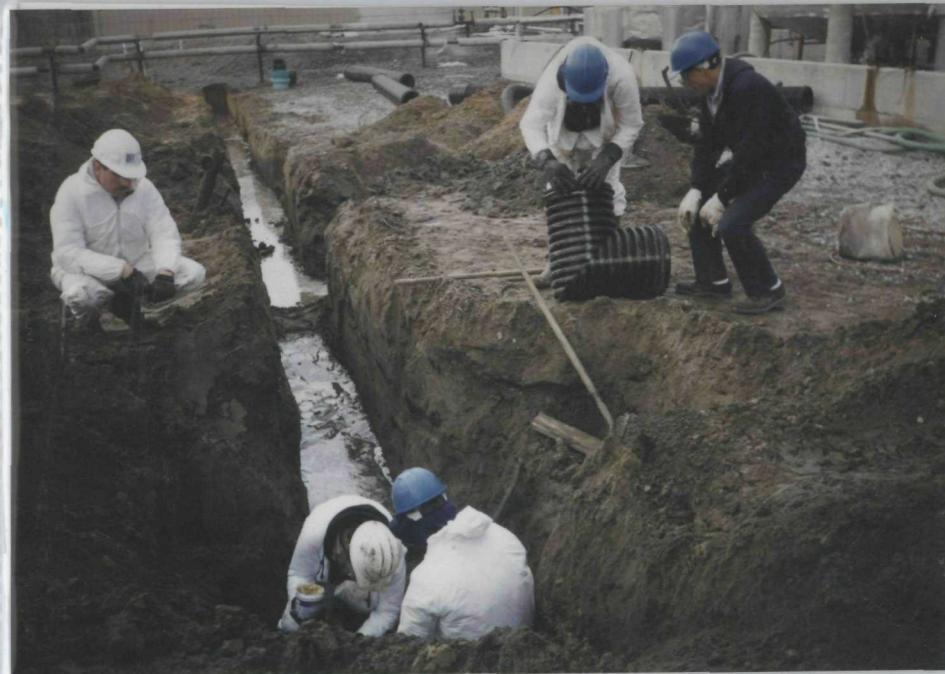
Description: Facing west. Installing an 80 feet long, 12-inch collection pipe for the stormwater collection system, just north of the three settling tanks.

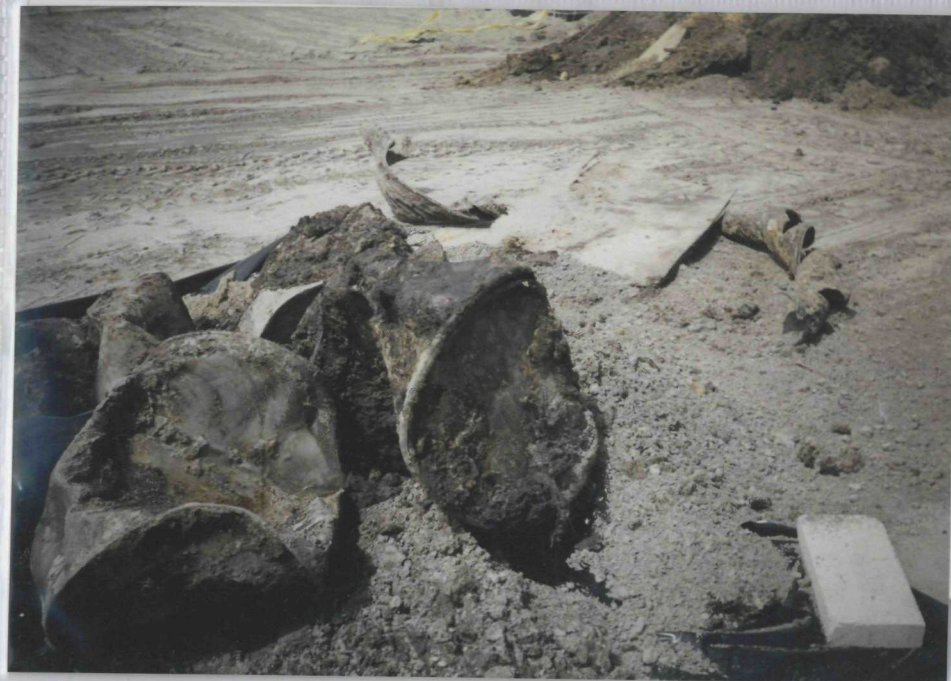
Description: Facing west. Few buried drums were encountered while excavating to install stormwater piping east of the settling tanks.

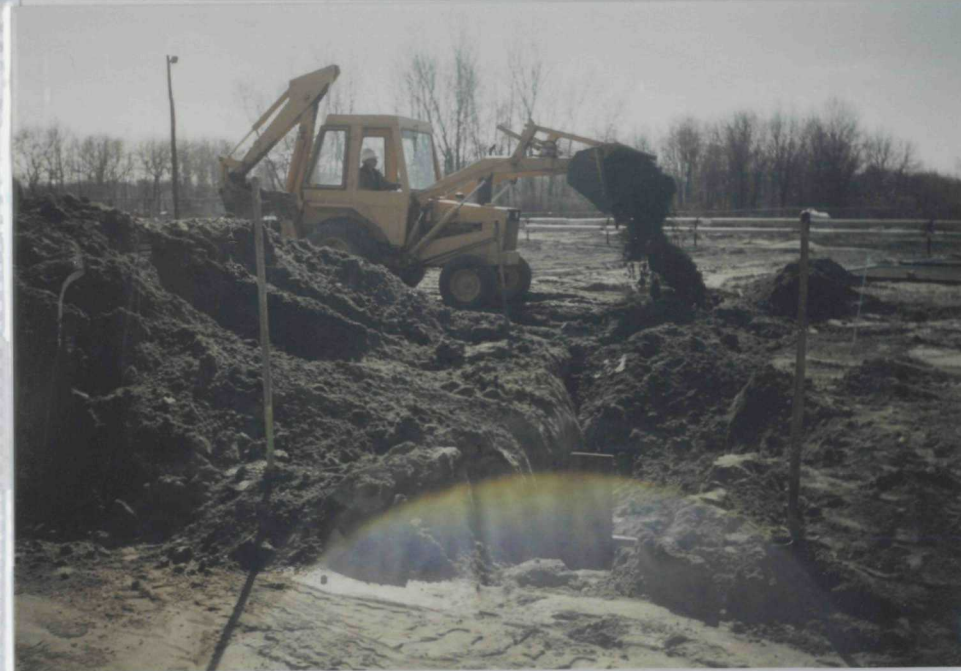
Site: American Chemical Services, Inc. RD/ERA  
 Proj. #: 71670.600  
 Roll: 4 Photo #: 113  
 Date: 04-22-97 Time: 1230  
 Photographer: Ashok Rupani  
 Description: Facing east. Installing stormwater piping just east of the settling tanks.

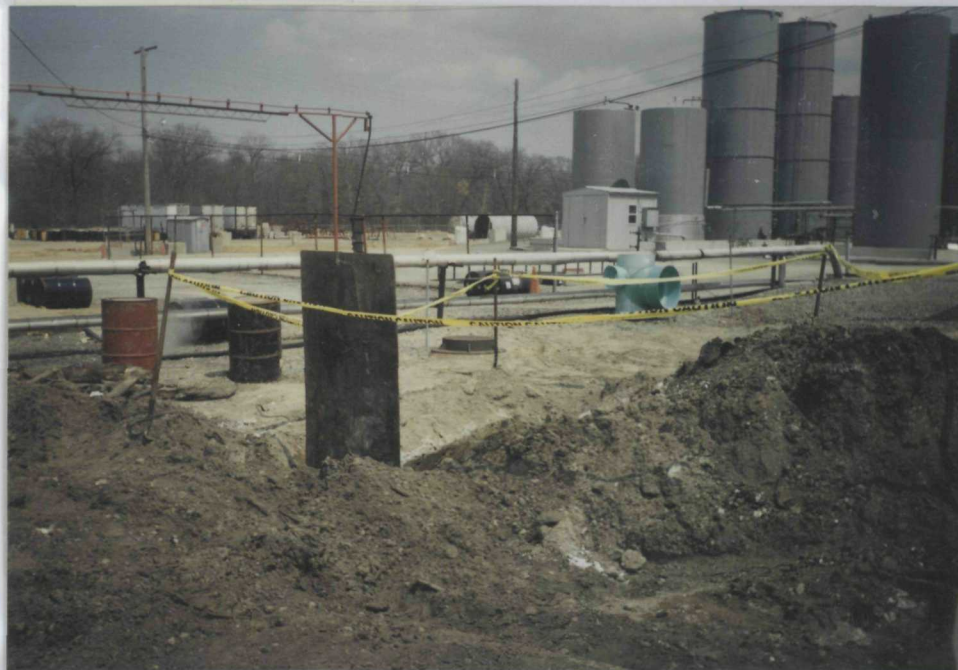
Site: American Chemical Services, Inc. RD/ERA  
 Proj. #: 71670.600  
 Roll: 5 Photo #: 115  
 Date: 04-28-97 Time: 1320  
 Photographer: Ashok Rupani  
 Description: Facing north-east. The 24-inch inflow line was temporarily capped until the stormwater manhole was installed.

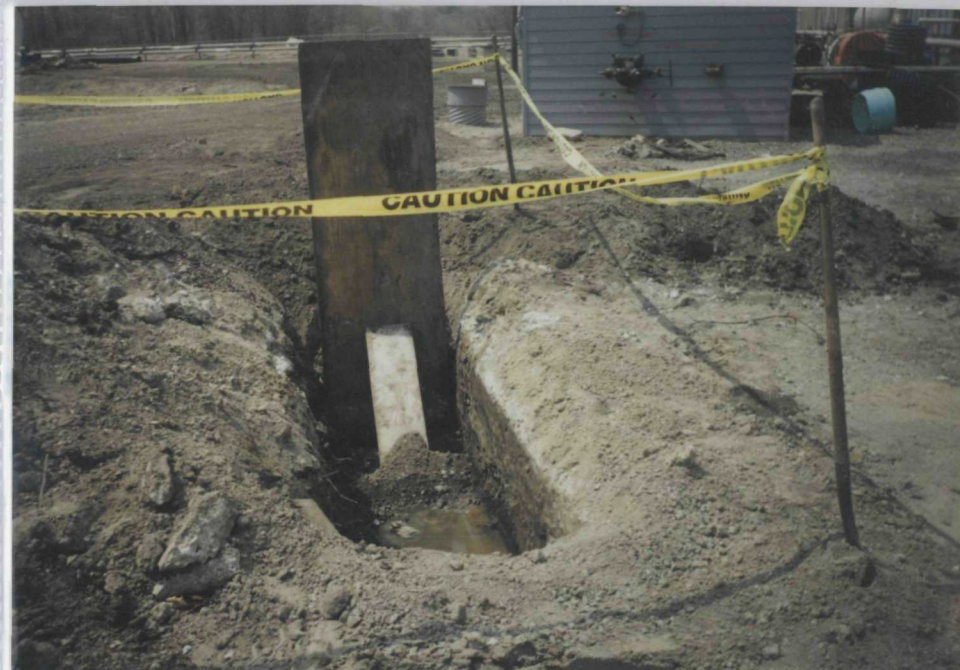
Site: American Chemical Services, Inc. RD/ERA  
 Proj. #: 71670.600  
 Roll: 5 Photo #: 116  
 Date: 04-28-97 Time: 1320  
 Photographer: Ashok Rupani  
 Description: Facing south-west. The 24-inch inflow line was temporarily capped until the stormwater manhole was installed.

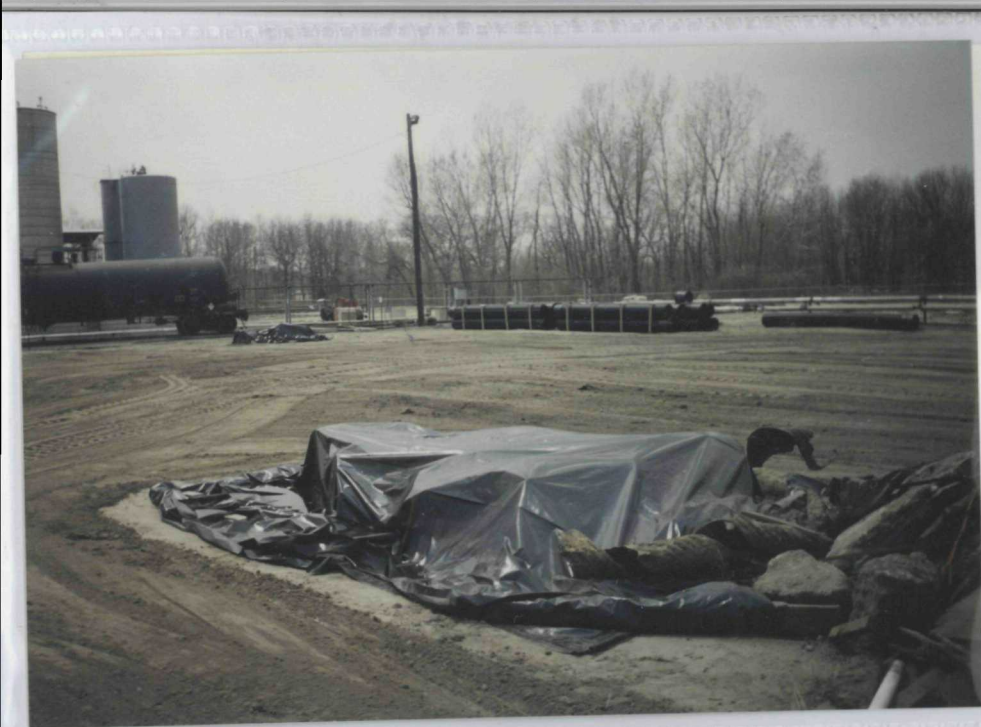
Site: American Chemical Services, Inc. RD/ERA  
 Proj. #: 71670.600  
 Roll: 5 Photo #: 119  
 Date: 04-28-97 Time: 1345  
 Photographer: Ashok Rupani  
 Description: Facing south. Drums shown in Photo #s 111 and 112 were temporarily covered with plastic.

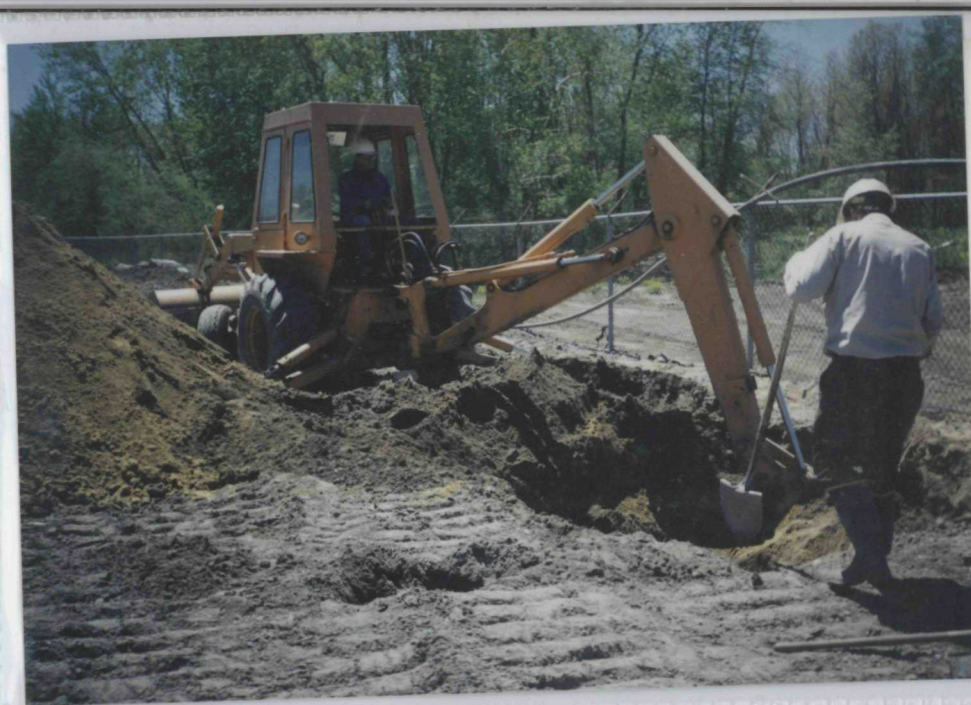
Site: American Chemical Services, Inc. RD/ERA  
 Proj. #: 71670.600  
 Roll: 7 Photo #: 120  
 Date: 05-21-97 Time: 1300  
 Photographer: Ashok Rupani  
 Description: Facing west. ACS personnel excavating to install a section of the stormwater piping through the barrier wall by cutting a hole in the wall and welding an HDPE sleeve on to the wall.

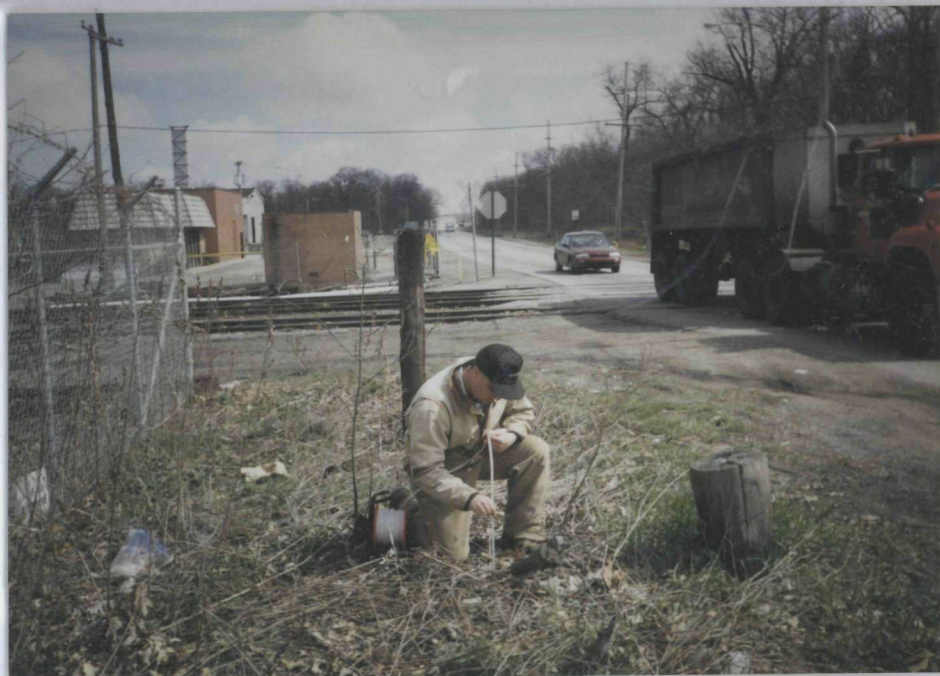
Description: Facing north. An underground storage tank was found just outside the main entrance to the Offsite Containment Area. The photo shows Montgomery Watson personnel gauging the depth of the tank.
